**Flood Control Project Maintenance
Levee Inspections**

Fall 2015 Levee Maintenance Deficiency Summary Report

Reclamation District No. 0307 Lisbon

Unit Cover Sheet

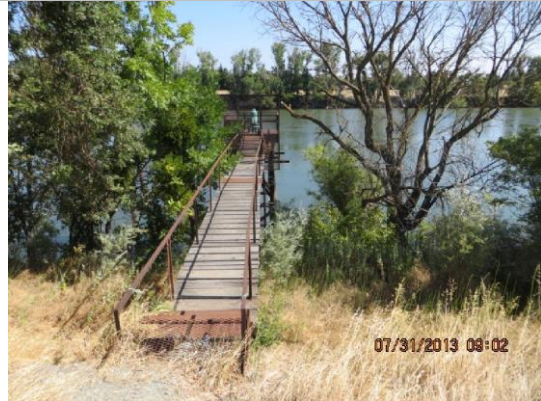
Photo 2 of 3 : UCIP_FA_2015_0997.jpg

Conduit visible under first step of walkway to pump on WS shoulder.

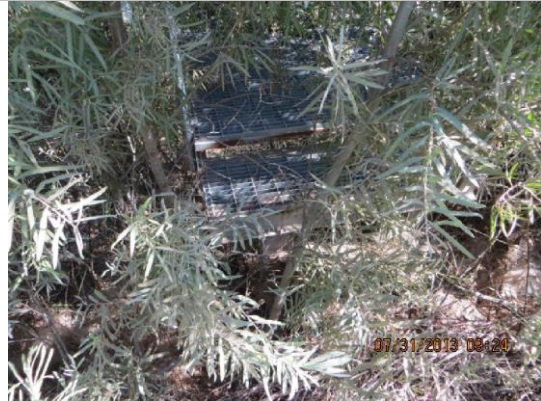
Photo 2 of 3 : UCIP_FA_2015_1397.jpg

Inspector Comments: FS_ID:16766
 DS_ID:21660
 EP_NO: 3324
 FS_HLM: 1.098
 Repair Type: Non-Urgent
 Crossing Status: Found
 UCIP Comments: Walkway completely obscured by vegetation on WS slope.
 FIELD_STRUCT_DESC: 1.25-inch electrical conduit through the levee 10.0 feet below the crown. Corrugated metal stage recorder house and walkway on the waterward slope. Service pole on the landward slope (Permit No. 3324, 1960).
 FS Date: 07/31/2013

Metal walkway visible in brush on WS slope.

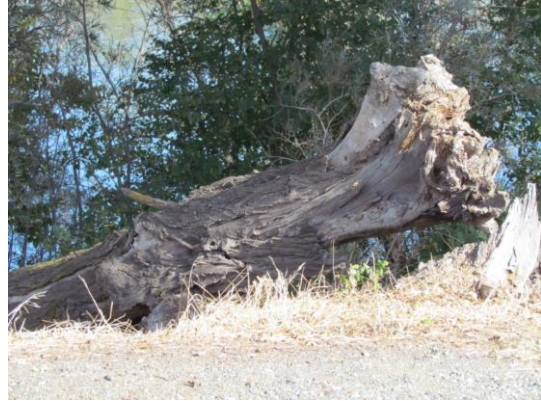
Photo 1 of 1 : FA_2015_RD0307_166_9_20150915_00001.jpg

LM Start	1.29	Rating **	U	Issue No.	9
LM End	1.29	Issue Type +	En	Location *	WS
Category	Earthen Levee			GPS Latitude/Longitude	
				Start	End
Item	Encroachments			38.472827 °	38.472827 °
				-121.528785 °	-121.528785 °
DWR ID	DWR_RD0307_01_f_2014_9				
Action/Comments					
Tree or limb					
Inspector Comments: I have instructed the RD to schedule with his contractor to cut this tree up and have it removed from the levee section.

This tree needs to be removed from the waterside slope.

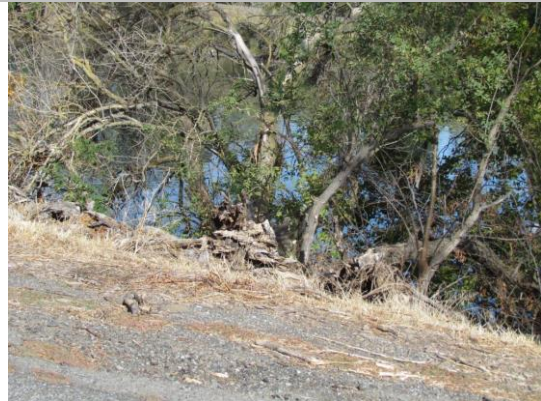
Photo 1 of 1 : FA_2015_RD0307_166_10_20150915_00002.jpg

LM Start	1.35	Rating **	M	Issue No.	10
LM End	1.35	Issue Type +	En	Location *	WS
Category	Earthen Levee			GPS Latitude/Longitude	
				Start	End
Item	Encroachments			38.472880 °	38.472880 °
				-121.527733 °	-121.527733 °
DWR ID	DWR_RD0307_01_f_2014_10				
Action/Comments					
Tree or limb					
Inspector Comments: The RD will schedule to have these trees cut up and removed from the waterside levee section as soon as possible.

Remove unwanted trees from waterside slope. These trees are dead and are resting on the slope.

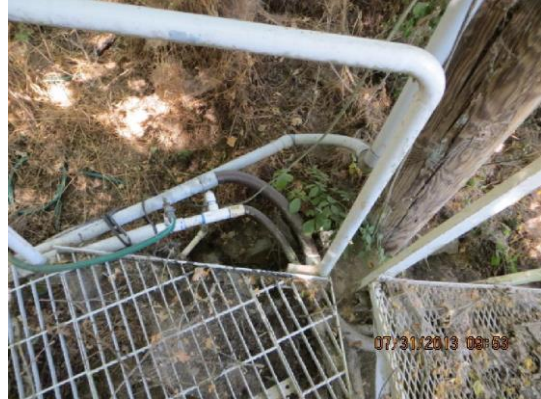
Photo 1 of 3 : UCIP_FA_2015_1002.jpg

Pipes visible under metal ramp on WS slope.

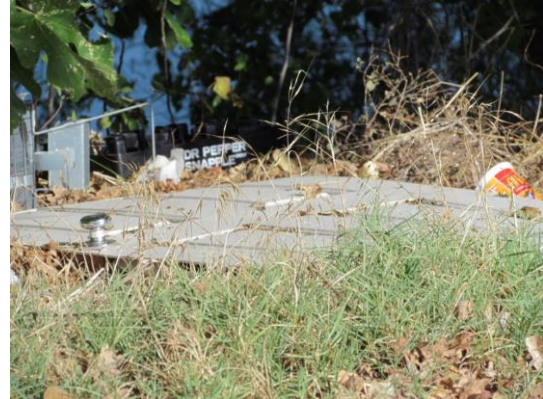
Photo 1 of 1 : FA_2015_RD0307_166_14_20150915_00003.jpg

LM Start	1.69	Rating **	U	Issue No.	14
LM End	1.79	Issue Type +	En	Location *	WS
Category	Earthen Levee			GPS Latitude/Longitude	
				Start	End
Item	Encroachments			38.473243 °	38.473277 °
				-121.521460 °	-121.519537 °
DWR ID	DWR_RD0307_01_f_2014_14				
Action/Comments					
Garbage					
Inspector Comments: Remove encroachments from levee section waterward slope.

Garbage and debris dumped on waterside levee slope.

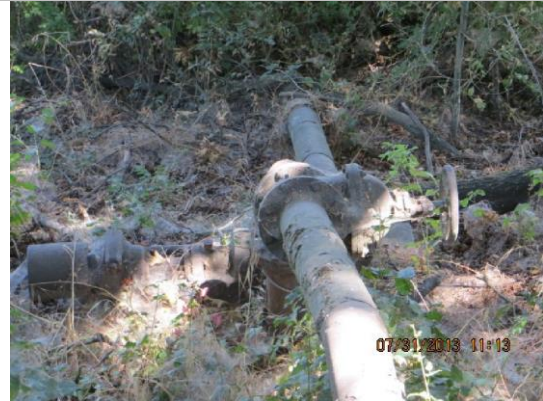
Photo 2 of 3 : UCIP_FA_2015_1444.jpg

Inspector Comments: FS_ID:40794
 DS_ID:21667
 EP_NO: N/A
 FS_HLM: 2.452
 Repair Type: Non-Urgent
 Crossing Status: Found
 UCIP Comments: Pipe appears abandoned and if so should be done so properly.
 FIELD_STRUCT_DESC: 6-inch steel irrigation pipe through the levee 3.0 feet below the crown. Pump and gate valve on the waterward slope. 36-inch concrete standpipe on LS toe. Originally included in the 1959 O&M manual.
 FS Date: 07/31/2013

Pump and gate valve on WS slope.

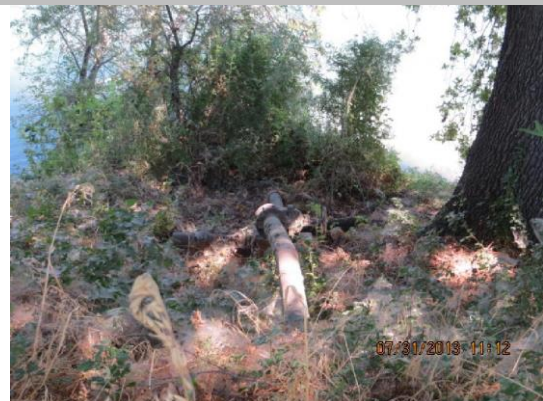
Photo 3 of 3 : UCIP_FA_2015_1445.jpg

Pump and gate valve on WS slope.

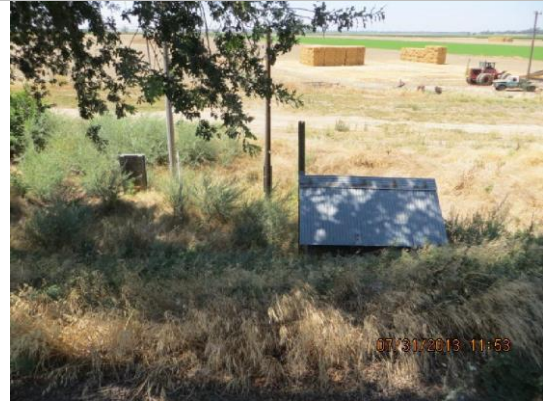
Photo 2 of 2 : UCIP_FA_2015_1464.jpg

Pumphouse on LS toe.

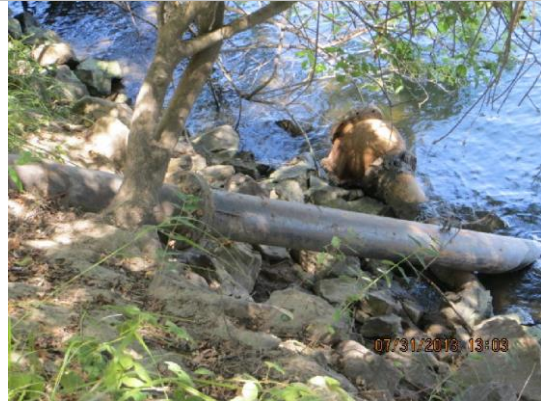
Photo 1 of 2 : UCIP_FA_2015_1465.jpg

Pipe visible on WS toe.

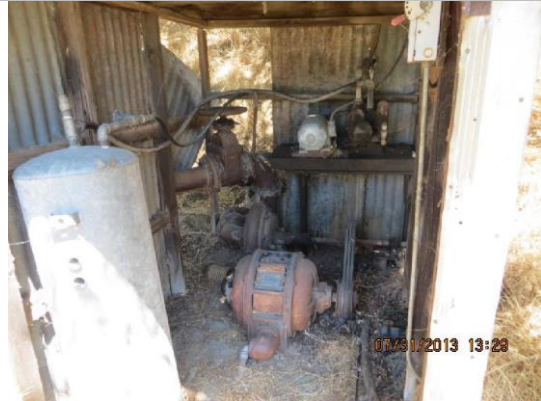
Photo 1 of 3 : UCIP_FA_2015_1053.jpg

Gate valve and pump in pumphouse on LS toe.

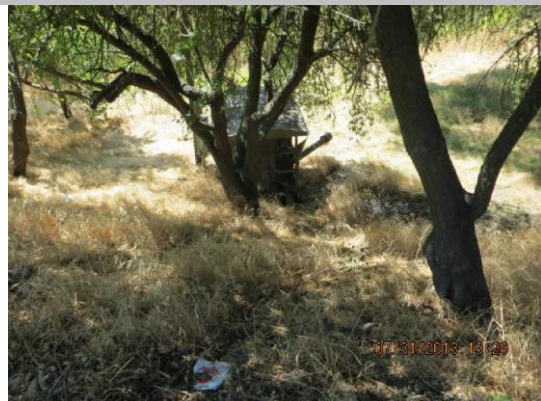
Photo 2 of 3 : UCIP_FA_2015_1054.jpg

Pumphouse on LS toe.

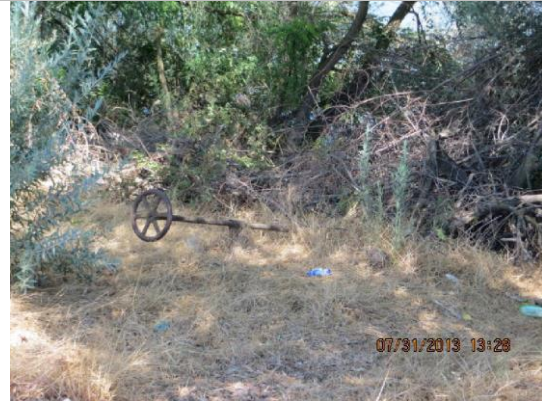
Photo 3 of 3 : UCIP_FA_2015_1055.jpg

Gate valve actuator on WS slope.

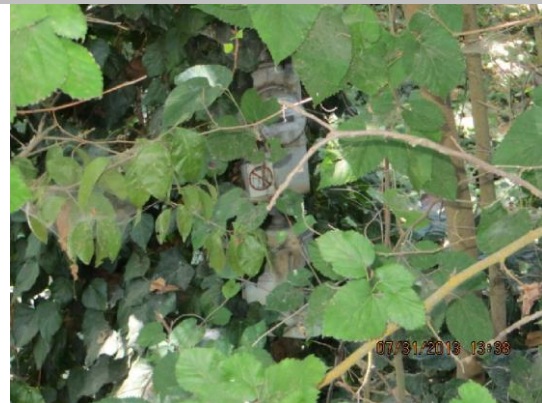
Photo 1 of 2 : UCIP_FA_2015_1075.jpg

JP and meter on LS toe.

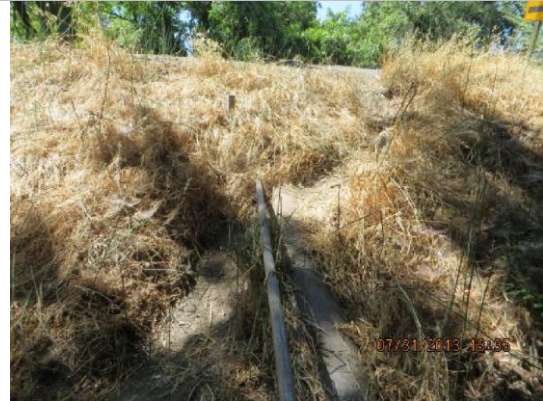
Photo 2 of 2 : UCIP_FA_2015_1076.jpg

Conduit visible on WS slope.

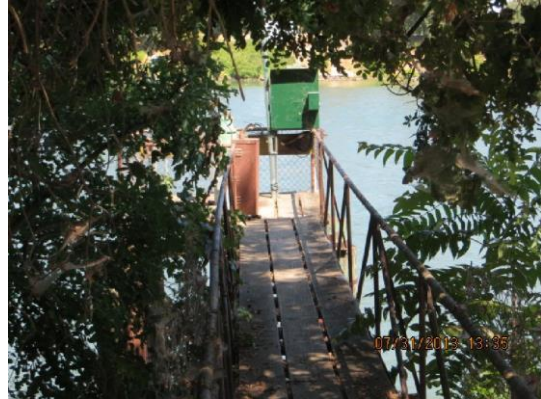
Photo 2 of 3 : UCIP_FA_2015_1073.jpg

Pump and electrical controls on Pier at WS slope.

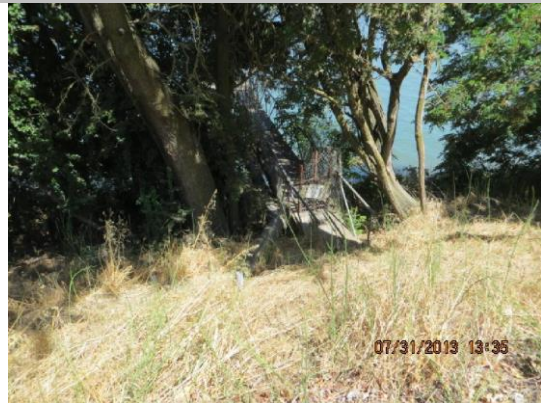
Photo 3 of 3 : UCIP_FA_2015_1074.jpg

Pipe and walkway visible on WS slope.

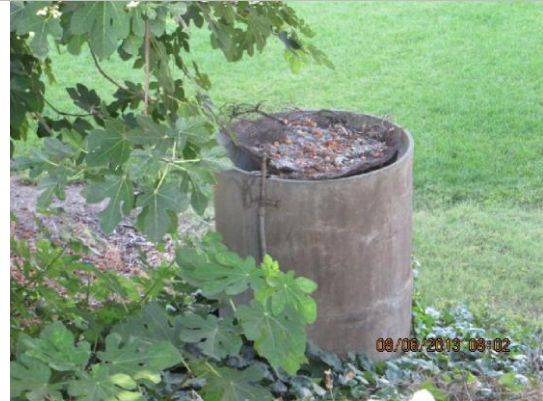
Photo 1 of 3 : UCIP_FA_2015_1123.jpg

48-inch concrete standpipe on LS toe.

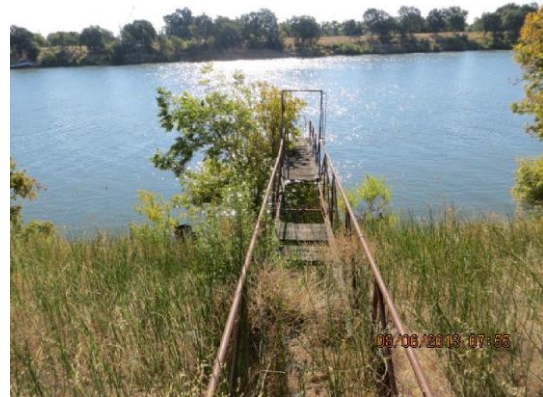
Photo 3 of 3 : UCIP_FA_2015_1125.jpg

Metal walkway to pump on pier and gate valve actuator on WS slope.

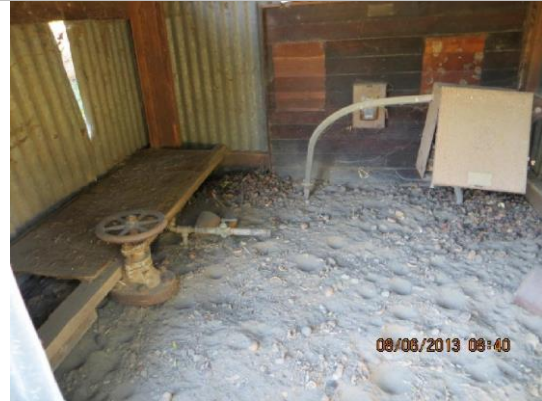
Photo 1 of 3 : UCIP_FA_2015_1611.jpg

Gate valve in pumphouse on LS toe. pumphouse filled with soil.

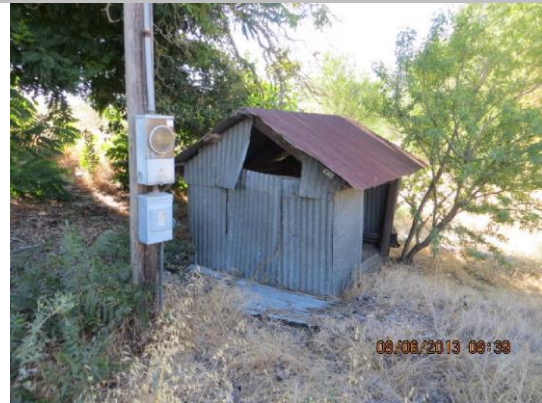
Photo 2 of 3 : UCIP_FA_2015_1612.jpg

Power Pole, meter, and pumphouse on LS toe.

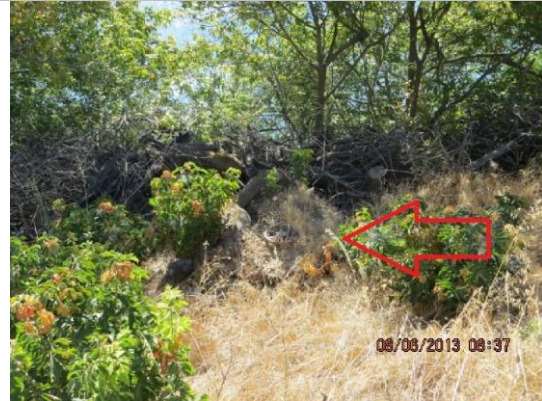
Photo 3 of 3 : UCIP_FA_2015_1613.jpg

Wooden lid at gate valve in CMP riser on WS slope.

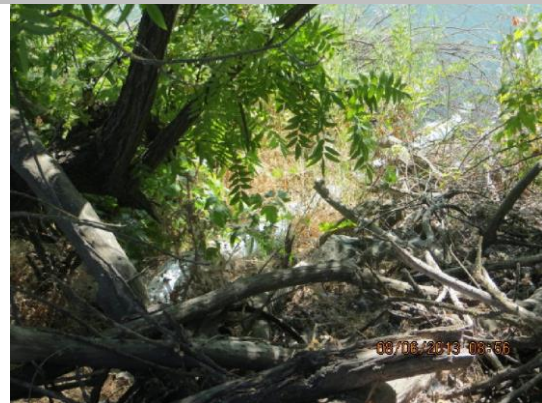
Photo 1 of 2 : UCIP_FA_2015_2074.jpg

Pipe visible on WS slope.

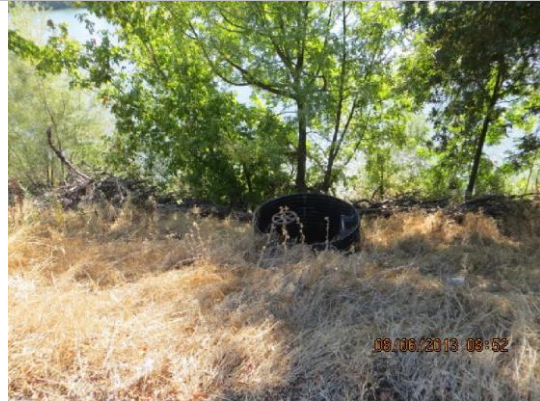
Photo 2 of 2 : UCIP_FA_2015_2075.jpg

Slide gate in riser on WS slope.

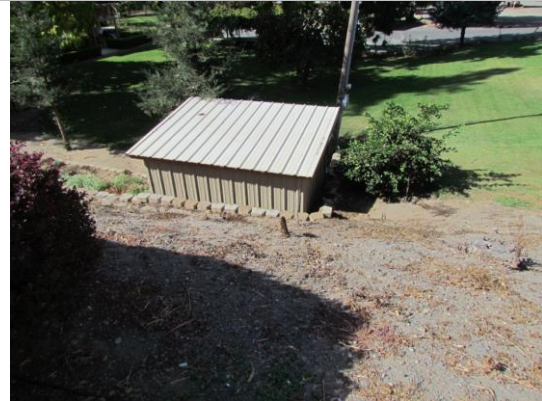
Photo 1 of 1 : FA_2015_RD0307_166_26_20150915_00004.jpg

LM Start	4.31	Rating **	U	Issue No.	26
LM End	4.31	Issue Type +	En	Location *	LS
Category	Earthen Levee			GPS Latitude/Longitude	
				Start	End
Item	Encroachments			38.444612 °	38.444612
				-121.503100 °	-121.503100
DWR ID	DWR_RD0307_01_f_2014_26				
Action/Comments					
Building					
Inspector Comments: This pumphouse was built without a permit, the district is aware of the encroachment.

This pump house was built without CVFPB Permit.

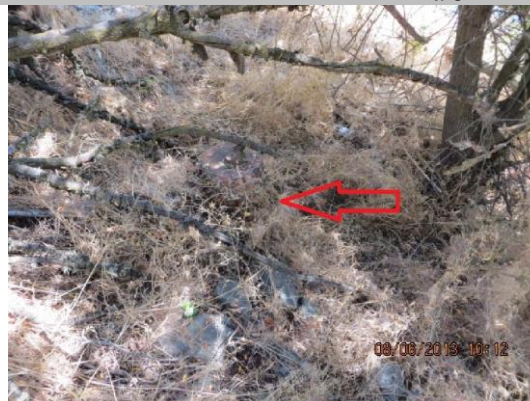
Photo 1 of 2 : UCIP_FA_2015_1614.jpg

Gate valve on WS slope.

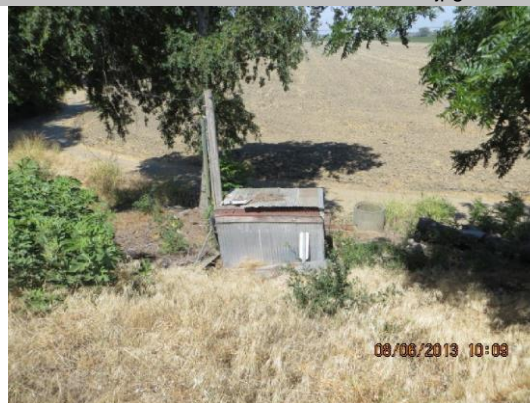
Photo 2 of 2 : UCIP_FA_2015_1615.jpg

Pumphouse for 6-inch pipe at LS toe.

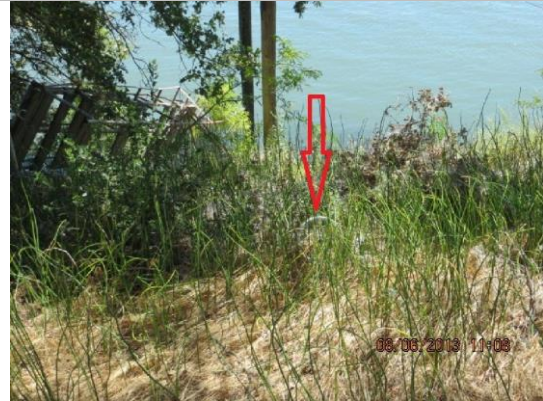
Photo 1 of 3 : UCIP_FA_2015_1616.jpg

Gate valve actuator on WS slope.

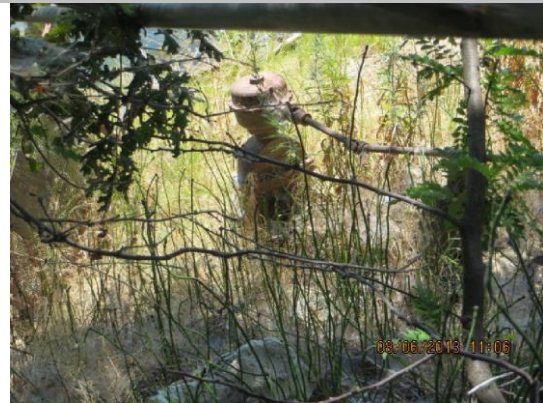
Photo 2 of 3 : UCIP_FA_2015_1617.jpg

Gate valve on WS slope.

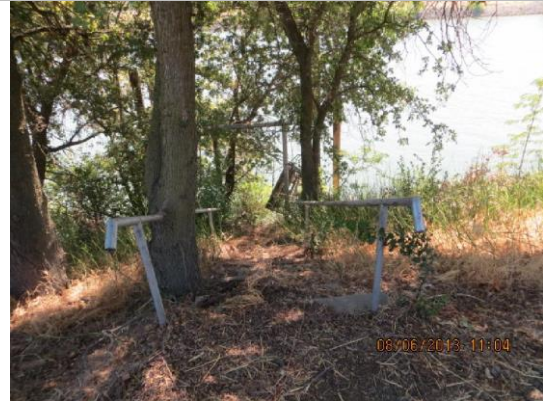
Photo 3 of 3 : UCIP_FA_2015_1618.jpg

Pipe and gate valve on WS slope just downstream from stairs.

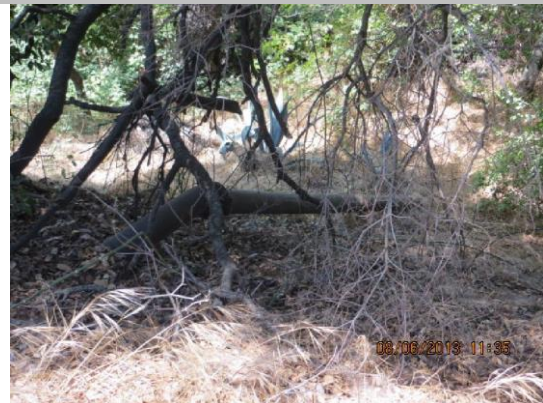
Photo 1 of 1 : UCIP_FA_2015_2076.jpg

LM Start	4.82	Rating **	M	Issue No.	91
LM End	4.82	Issue Type +	En	Location *	LS
Category	Supplemental			GPS Latitude/Longitude	
				Start	End
Item	DWR UCIP Field Study			38.438390 °	38.438390 °
				-121.507323 °	-121.507323 °
DWR ID					
Action/Comments					
Inspector Comments: FS_ID:22671					
DS_ID:21693					
EP_NO: N/A					
FS_HLM: 4.88					
Repair Type: Non-Urgent					
Crossing Status: Found					
UCIP Comments: Pipe abandoned and should be done so properly.					
FIELD_STRUCT_DESC: 1 of 2: 6-inch steel irrigation pipe through the					
levee 1.5 feet below the crown Originally included in the 1959 O&M					
manual.					
FS Date: 08/06/2013

Pipe visible on LS slope.

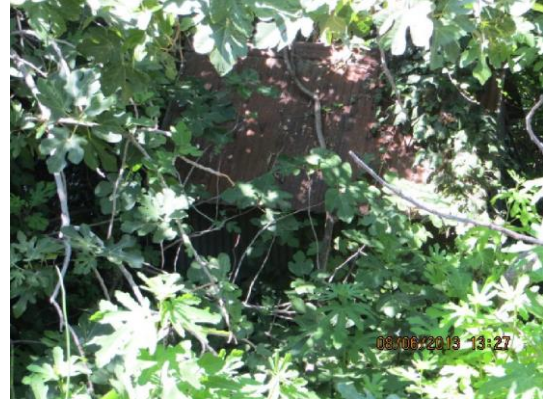
Photo 1 of 3 : UCIP_FA_2015_2467.jpg

Inspector Comments: FS_ID:22710
 DS_ID:21698
 EP_NO: 8048
 FS_HLM: 5.3
 Repair Type: Non-Urgent
 Crossing Status: Found
 UCIP Comments: Pipe appears abandoned and should be done so properly.
 FIELD_STRUCT_DESC: 6-inch steel irrigation pipe through levee 14.5 feet below crown. Gate valve in 5-foot diameter CMP riser on the WS slope. Pump and gate valve in pumphouse on LS toe. 36-inch concrete standpipe on LS of pumphouse (Permit No. 8048, 1972). Included in the 1959 O&M manual.
 FS Date: 08/06/2013

Pumphouse on LS toe.

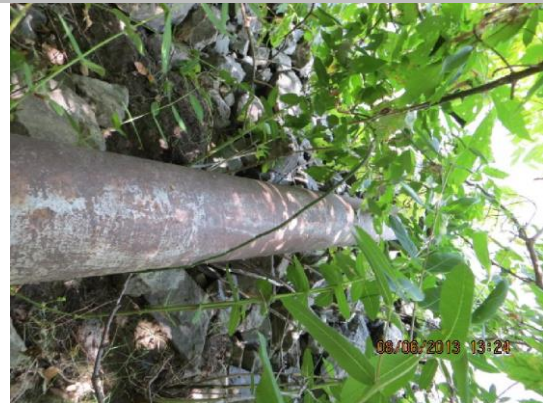
Photo 2 of 3 : UCIP_FA_2015_2468.jpg

Pipe visible on WS slope.

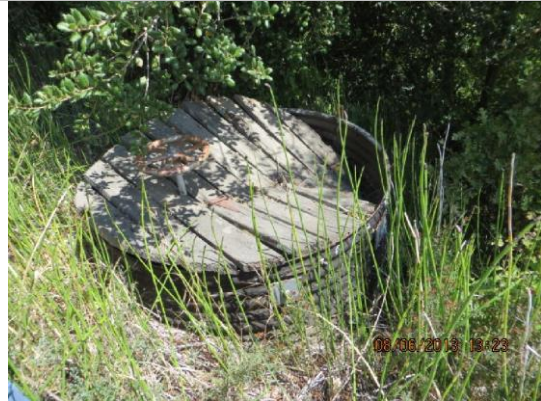
Photo 3 of 3 : UCIP_FA_2015_2469.jpg

Gate valve in 5-foot diameter CMP riser on WS slope.

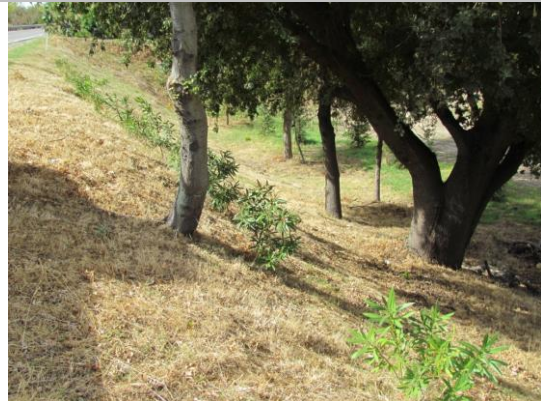
Photo 1 of 4 : FA_2015_RD0307_166_28_20150915_00006.jpg

LM Start	5.33	Rating **	U	Issue No.	28
LM End	5.44	Issue Type +	En	Location *	LS
Category	Earthen Levee			GPS Latitude/Longitude	
				Start	End
Item	Encroachments			38.435728 °	38.435610 °
				-121.516023 °	-121.518140 °
DWR ID	DWR_RD0307_01_f_2014_28				
Action/Comments					
Tree or limb					
Inspector Comments: Unauthorized planting of small oleander trees on the shoulder and young fig trees placed on the landside levee toe.					
There are more than 15 trees at this location.

Looking downstream from levee mile 5.33 landward at small trees planted on the levee section.

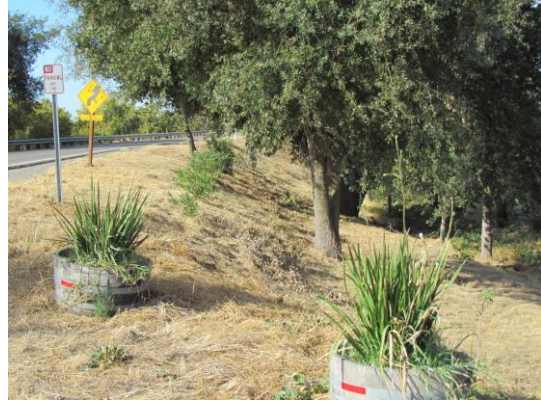
Photo 3 of 4 : FA_2015_RD0307_166_28_20151019_00034.jpg

The land owner has planted oleander trees and fig trees on the landside toe.

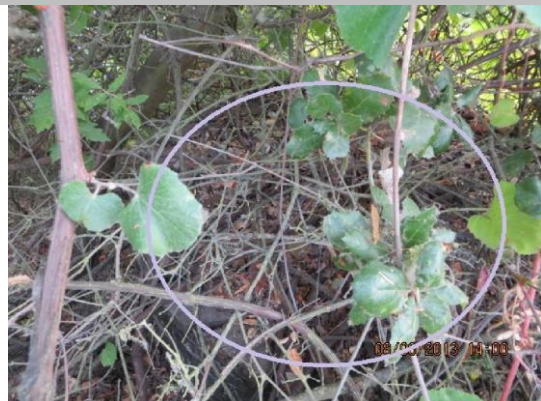
Photo 1 of 2 : UCIP_FA_2015_0532.jpg

Gate valve in 5-foot diameter CMP riser on WS slope.

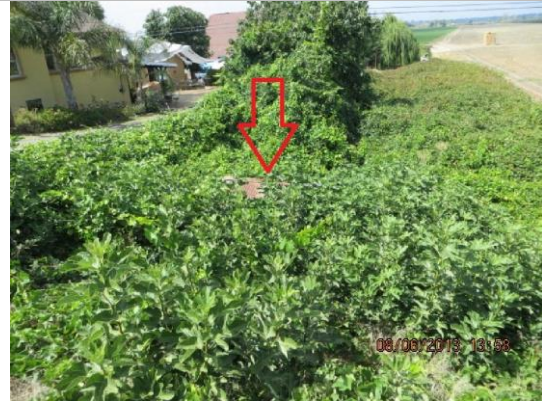
Photo 2 of 2 : UCIP_FA_2015_0533.jpg

Pumphouse on LS toe.

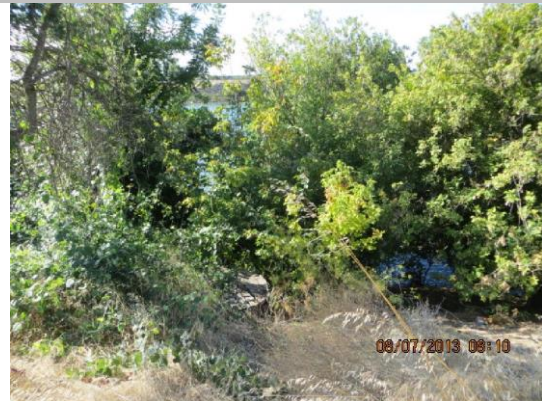
Photo 1 of 2 : UCIP_FA_2015_0534.jpg

Gate valve in 5-foot diameter CMP riser on WS slope.

Action/Comments					
Inspector Comments: FS_ID:17287 DS_ID:21701 EP_NO: 8050 FS_HLM: 5.554 Repair Type: Non-Urgent Crossing Status: Found UCIP Comments: Lid damaged on 5ft diameter riser on WS slope. Good candidate for video inspection as repair to pipe on LS toe is good indicator that pipe is failing internally. FIELD_STRUCT_DESC: 8-inch steel irrigation pipe through the levee 12.7 feet below the crown. Pump, vent, butterfly valve, 36-inch concrete standpipe, and power pole at LS toe. Gate valve in 5-foot diameter CMP riser on waterward slope (Permit No. 8050, 1972). Included in the 1959 O&M manual. FS Date: 08/07/2013

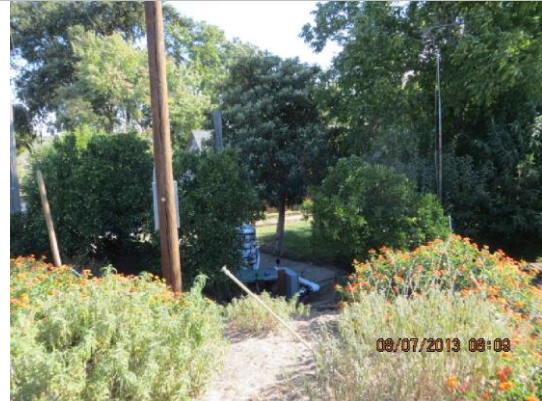
Photo 2 of 2 : UCIP_FA_2015_0535.jpg

Pump and appurtenances on LS toe.

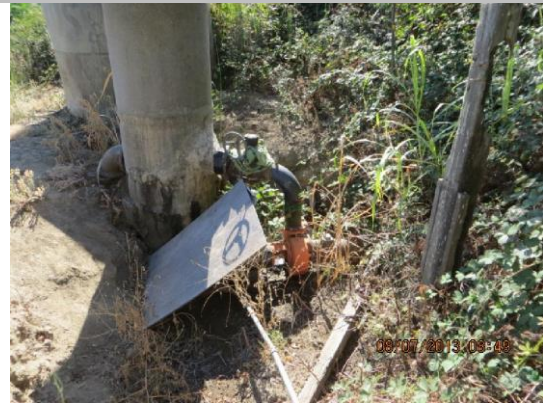
Photo 1 of 3 : UCIP_FA_2015_1381.jpg

Pump, butterfly valve, vent, and concrete standpipe on LS toe. Photo 3 description or comment here.

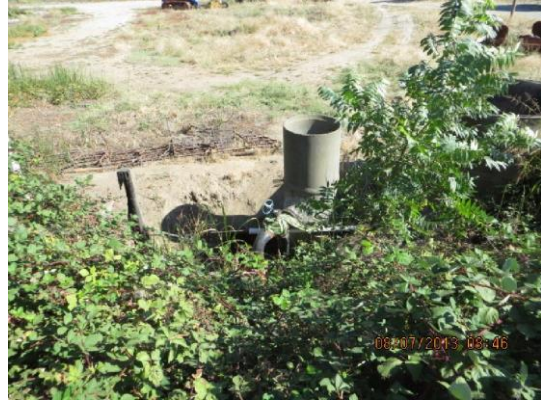
Photo 2 of 3 : UCIP_FA_2015_1382.jpg

Pump, butterfly valve, vent, and concrete standpipe on LS toe.

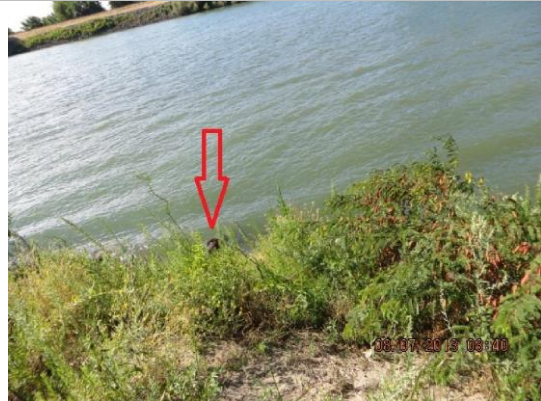
Photo 3 of 3 : UCIP_FA_2015_1383.jpg

Pipe visible on WS toe.

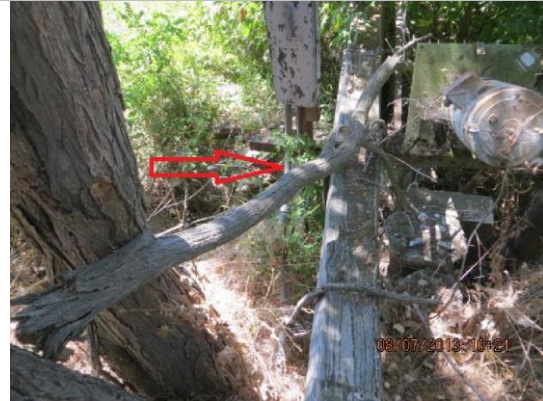
Photo 1 of 2 : UCIP_FA_2015_2482.jpg

Electrical conduit visible at panel next to slant pump on WS slope.

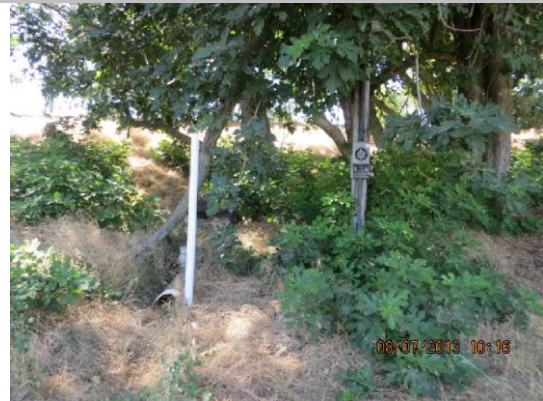
Photo 2 of 2 : UCIP_FA_2015_2483.jpg

Power pole and meter off LS toe.

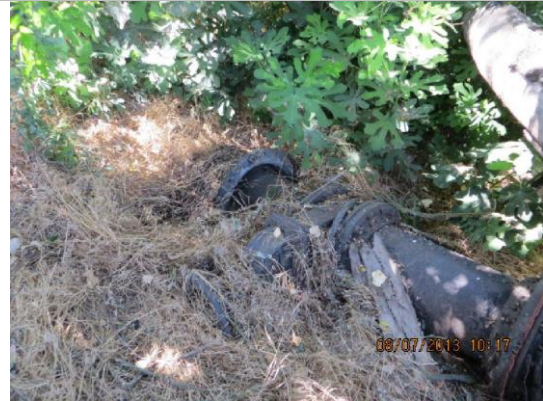
Photo 1 of 3 : UCIP_FA_2015_2484.jpg

Gate valve on LS toe.

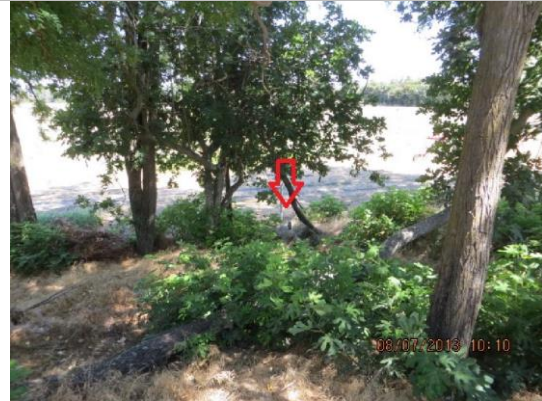
Photo 3 of 3 : UCIP_FA_2015_2486.jpg

Pipe on LS toe.

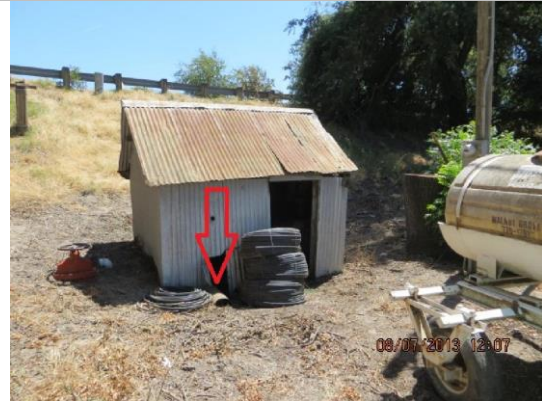
Photo 1 of 3 : UCIP_FA_2015_1661.jpg

Inspector Comments: FS_ID:17385
 DS_ID:21706
 EP_NO: 8057
 FS_HLM: 6.489
 Repair Type: Non-Urgent
 Crossing Status: Found
 UCIP Comments: Pipe appears abandoned and should be done so properly.
 FIELD_STRUCT_DESC: 10-inch steel irrigation pipe through the levee 13.8 feet below the crown. Pump and gate valve in pumphouse on the LS toe (Permit No. 8057, 1972). Originally included in the 1959 O&M manual.
 FS Date: 08/07/2013

Pipe cut and open on LS of pumphouse.

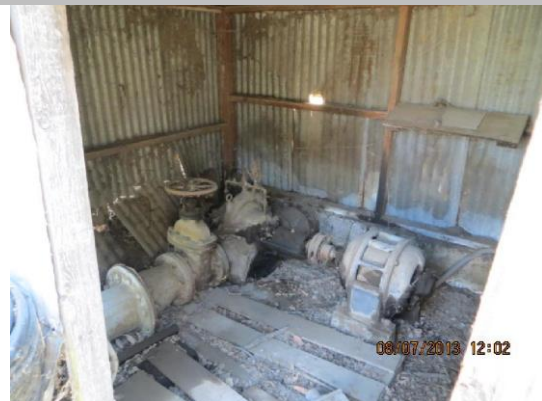
Photo 2 of 3 : UCIP_FA_2015_1662.jpg

Pump and gate valve inside pumphouse on LS toe.

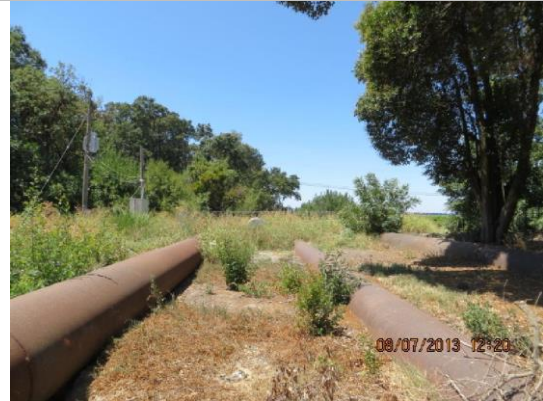
Photo 1 of 3 : UCIP_FA_2015_1541.jpg

Inspector Comments: FS_ID:17404
 DS_ID:21707
 EP_NO: 4096
 FS_HLM: 6.624
 Repair Type: Non-Urgent
 Crossing Status: Found
 UCIP Comments: Gate valve inaccessible to do fallen tree debris on steel platform.
 FIELD_STRUCT_DESC: 36-inch steel drain pipe through the levee 6-feet below the crown. Gate valve located just off LS toe on Steel platform. Pumping plant and trash rack located 200-feet off LS toe. Flap gate on the waterward end (Permit No. 4096, 1962). Replaced 36-inch pipe that was grouted in place at same location.
 FS Date: 08/07/2013

LM Start	6.54	Rating **	M	Issue No.	100 (cont)
LM End	6.54	Issue Type +	En	Location *	WS

Pipe visible on LS toe to pumping plant 200-feet off LS toe.

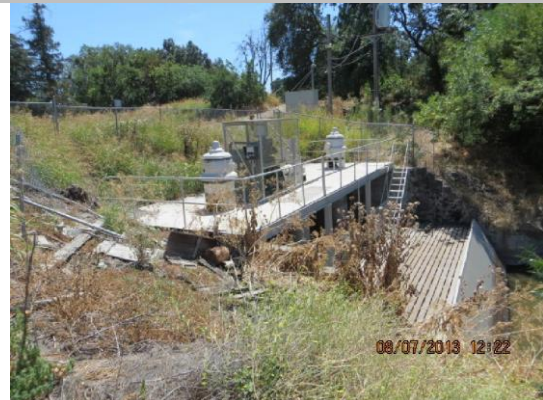
Photo 2 of 3 : UCIP_FA_2015_1664.jpg

Pumping plant and trash rack off LS toe.
